Accidents Waiting to Happen

Coal Ash Ponds Put Our Waterways at Risk

April 2018

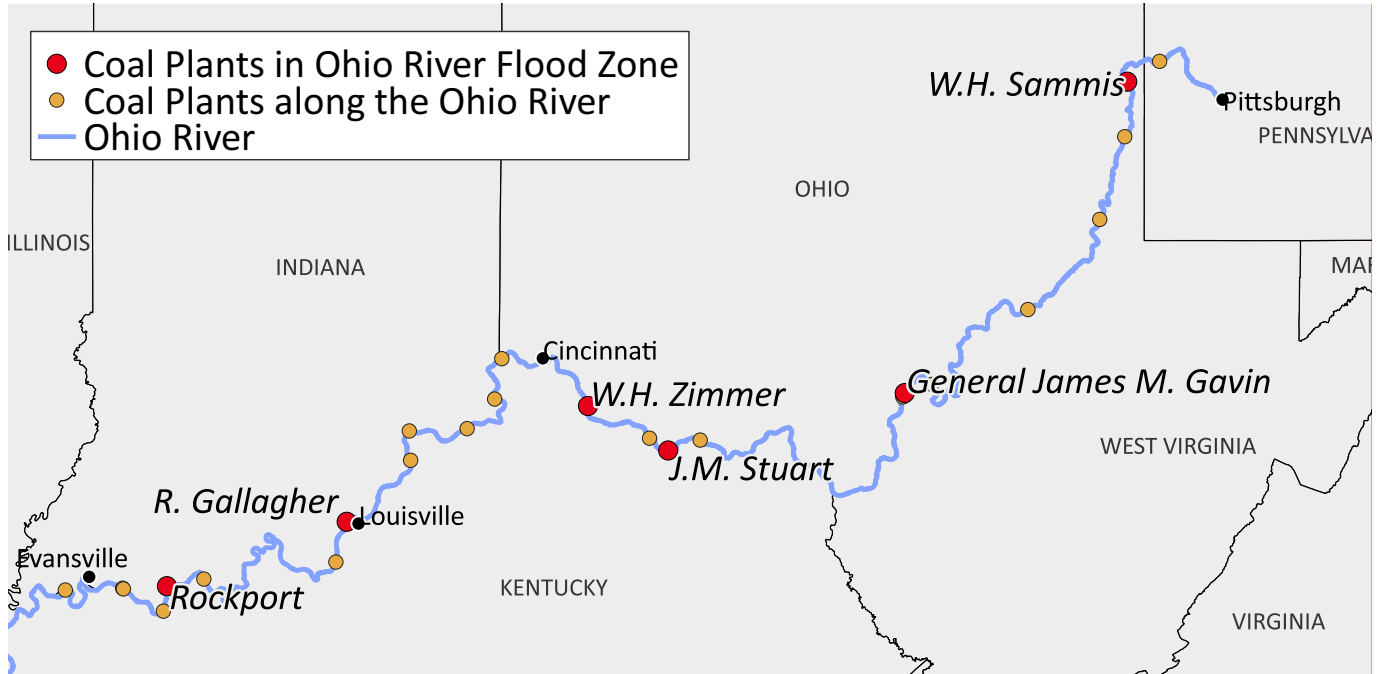
Figure ES-1. Coal Plants in 100-Year Flood Zones Along the Ohio River

Six coal plants lie in FEMA 100-year flood zones along the Ohio River. All have coal ash ponds on site, including four with coal ash ponds rated as “significant” hazards by a 2014 EPA assessment. Many more coal plants not in flood zones also sit along the banks of the Ohio River.

- Six coal plants lie in FEMA flood zones along the Ohio River, including five with coal ash ponds that the EPA found pose a “high” or “significant” hazard.

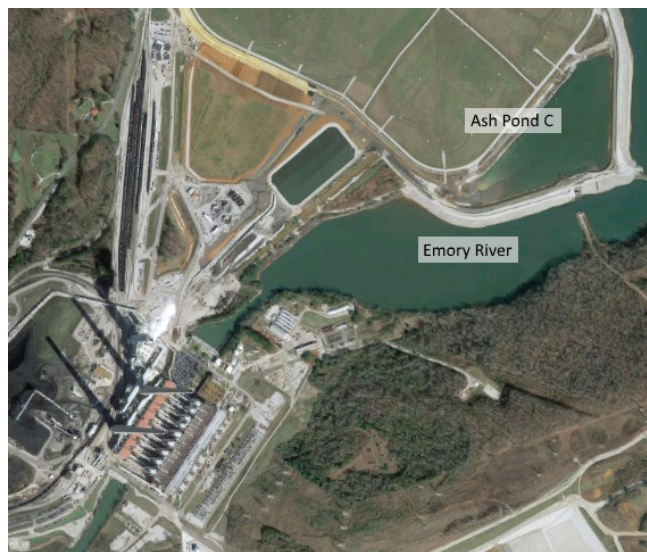
At the Kingston Fossil Plant, Ash Pond C contained decades worth of toxic coal ash waste. When the coal ash pond's dike failed, more than 1 billion gallons of coal ash waste flowed into the nearby Emory and Clinch rivers.¹² Image: U.S. EPA

can overflow and spill into nearby waterways.²⁹ The biggest spills have occurred because of retaining wall failures.³⁰ The hazard is increased for aging or poorly constructed ponds. In the case of the Kingston Fossil plant spill that resulted from a collapsed ash pond, the pond was more than 20 years old, and the retaining wall had been built on a layer of “slimes” consisting of old ash, river silt and clay runoff.³¹ When the slimes liquified after a heavy rain, the wall collapsed.³²

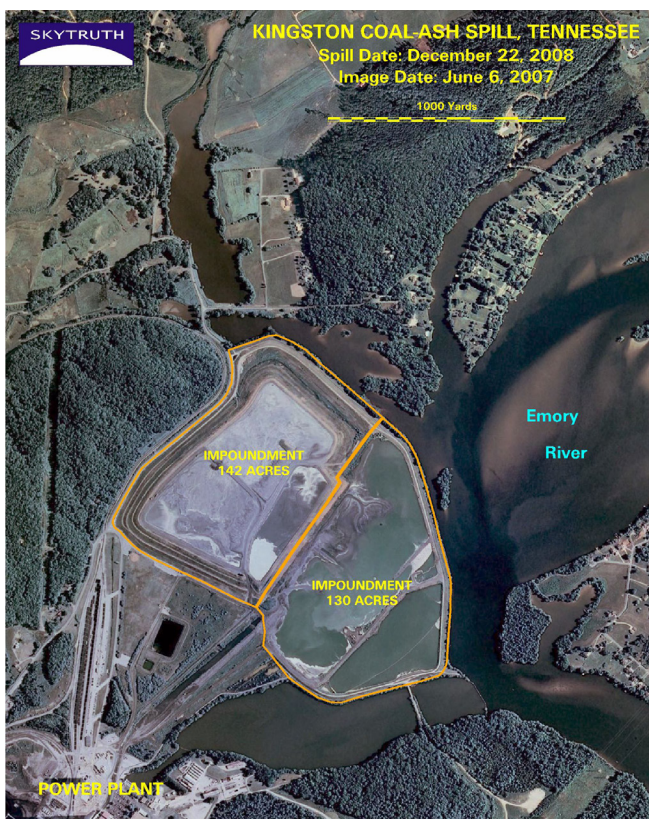
Often, coal ash ponds are separated from water by only a thin retaining wall, as was the case for a pond at the Kingston Fossil Plant in Tennessee, the site of one major spill. Credit: Skytruth via Flickr (CC BY-NC-SA 2.0)

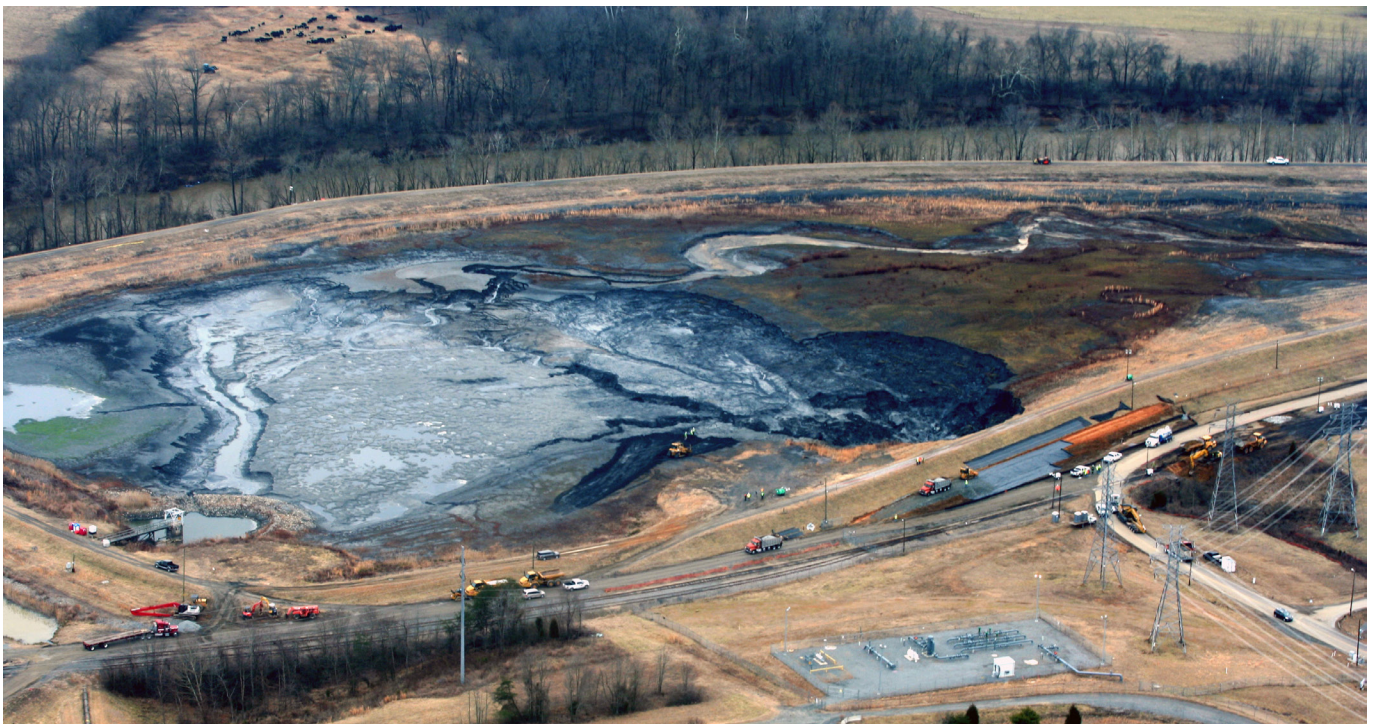
Coal ash spill into the Dan River in North Carolina, 2014. Photo credit: Waterkeeper Alliance/Rick Dove on Flickr (CC BY-NC 2.0)

In February 2014, 39,000 tons of coal ash and 27 million gallons of coal ash pond water spilled into the Dan River in Eden, North Carolina, after a pipe burst at Duke Energy's Dan River Steam Station, located at the river's edge.⁴² Although the plant had recently transitioned from coal to natural gas, the plant still stored more than one million tons of coal ash waste in ponds that were separated from the river by an earthen dam.⁴³ The coal ash contained arsenic, cadmium, chromium, mercury, selenium and other toxic substances.⁴⁴ The Dan River is home to two endangered species (the Roanoke logperch and the James spiny-mussel), is used for livestock watering and crop irrigation, and is a source of drinking water for residents in North Carolina and Virginia. In the wake of the spill, dead turtles were found onshore.⁴⁵ In an interview with the local Fox affiliate, Jenny Douglas of the Dan River Basin Association said "[t]urtles should be hibernating this time of year. It's cold. They hibernate down in the mud. The fact that they're crawling up on the bank and dying, even if it's not in mass numbers... It's highly unusual."⁴⁶ After the spill, indications of coal ash contamination were also detected in nearby wells.⁴⁷

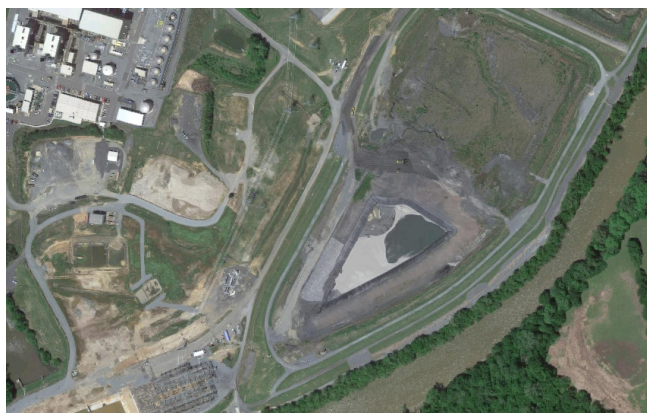
Overhead view of ash ponds at the Dan River Steam Station. Imagery ©2018 Google

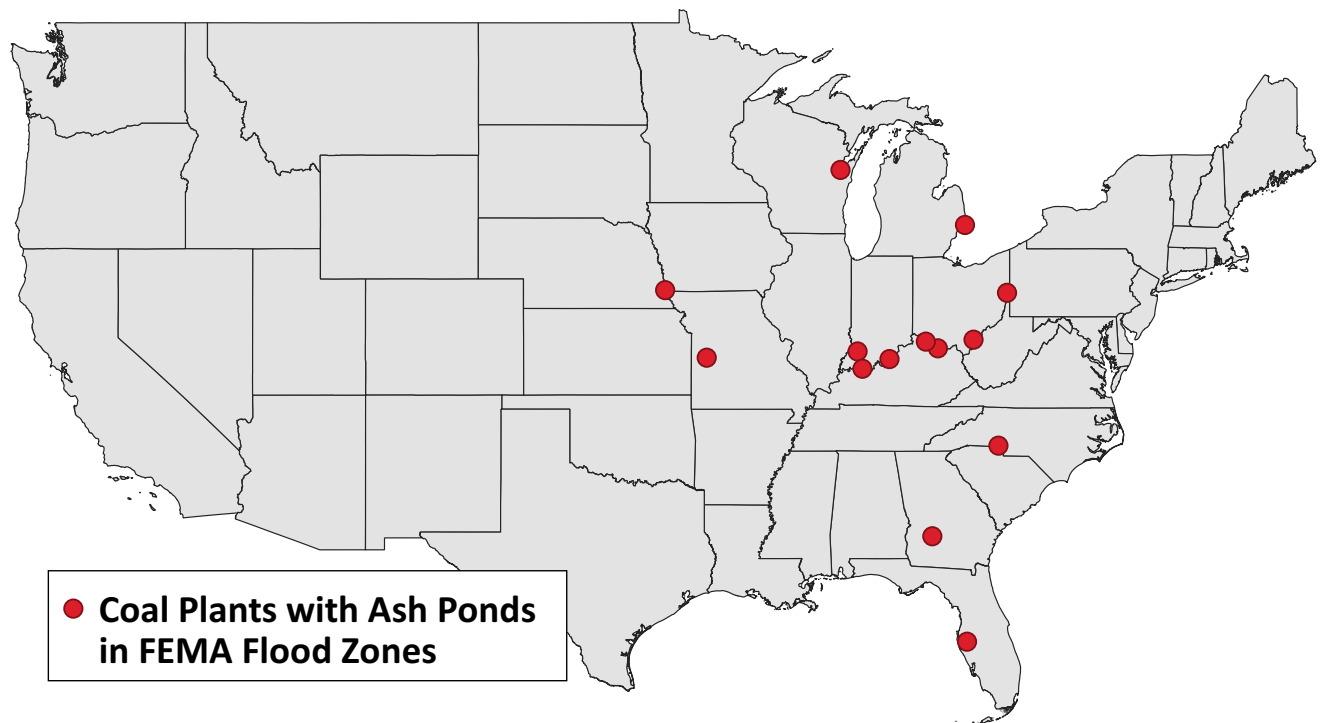
Figure 1. 14 U.S. Coal Plants with Coal Ash Ponds Lie in 100-Year Flood Zones

An analysis of coal plant location data finds that at least 14 U.S. coal plants with on-site coal ash ponds lie in FEMA 100-year flood zones. While hundreds of coal plant sites across the country likely put water at risk, those with coal ash ponds located in flood zones may pose an elevated threat, as being in a flood zone indicates both proximity to water and risk of flooding. (The estimate of coal plants in flood zones is likely conservative. See Methodology for details.)

These plants are home to at least 36 coal ash ponds and generate 8.4 million tons of coal ash each year.⁵⁴ Of the ponds that were included in a 2016 EPA survey, nine ponds were found to be in “fair” condition and eight in “poor” condition. Only seven of the ponds were found to be in “satisfactory” condition. Twelve of the ponds represented “significant” hazard potential in case of failure, indicating that impoundment failure would cause economic loss, environmental damage, or damage to infrastructure.⁵⁵

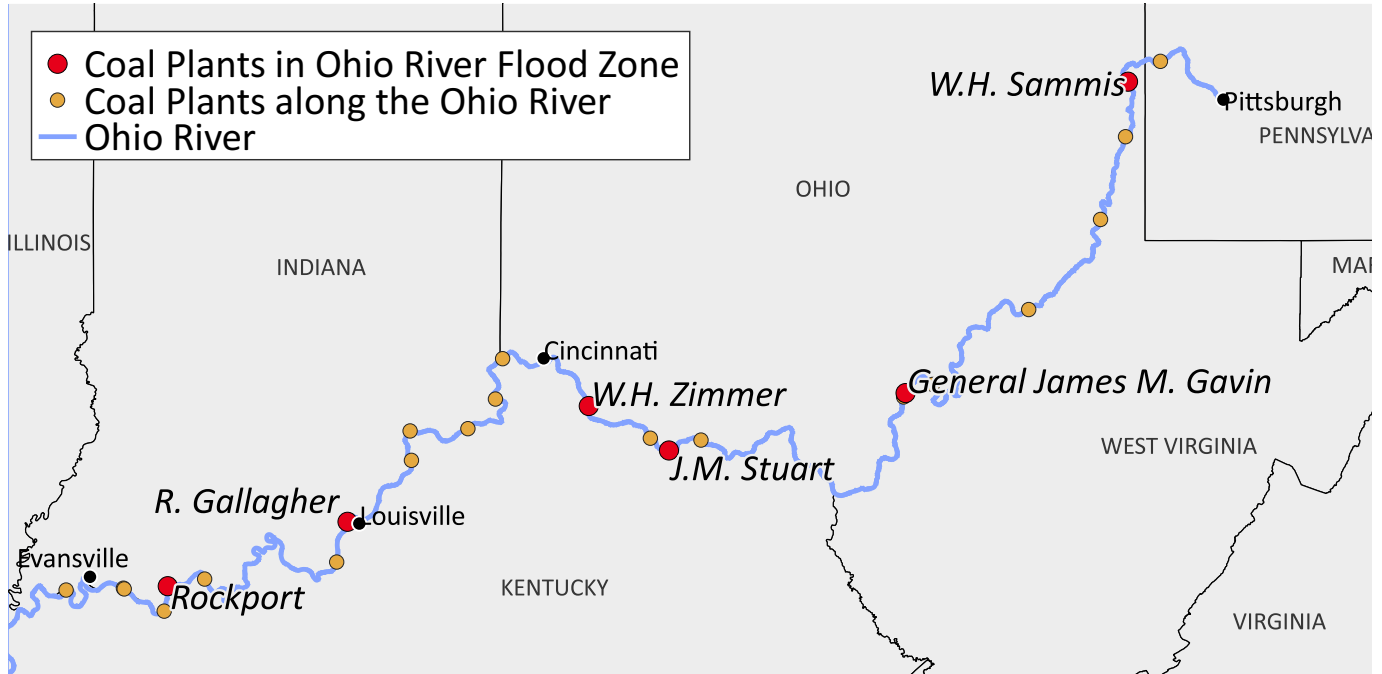
Figure 2. Coal Plants in 100-Year Flood Zones Along the Ohio River

Six coal plants lie in FEMA 100-year flood zones along the Ohio River. All have coal ash ponds on site, including four with coal ash ponds rated as “significant” hazards by a 2014 EPA assessment. Many more coal plants not in flood zones also sit along the banks of the Ohio River.

Many of these plants sit along the Ohio River. The Ohio River runs 981 miles, beginning in Pittsburgh, traversing the Appalachian coal region and providing the borders of Ohio, West Virginia, Indiana, and Kentucky until it flows into the Mississippi River in Illinois. Along the way, it supplies drinking water for more than 3 million people.⁵⁶ It also sustains hundreds of animal species, including 47 species of mussel (eight of which are endangered) and nearly 200 species of birds, and supports vibrant and unique riparian forests, including those of the Ohio River Islands National Wildlife Refuge.⁵⁷ The Ohio River also hosts more than 20 coal plants on its shores, which use the river’s water for cooling – and to fill coal ash ponds.

Of the 14 coal plants with ash ponds in flood zones nationwide, six are located along the Ohio River – four in Ohio and two in Indiana. Five of them – with a total of 11 coal ash ponds – were included in the EPA’s coal ash assessment report. Of those 11 ponds, the EPA found that only three were in “satisfactory” condition, and four posed either a “high” or “significant” hazard. The J.M. Stuart Station in Aberdeen, Ohio, had five coal ash ponds assessed, three of which were in “poor” condition. An analysis from 2009 showed that J.M. Stuart ranked 11th in the country for coal ash releases to surface impoundments, with 2.5 million pounds of coal ash stored in ponds.⁵⁸

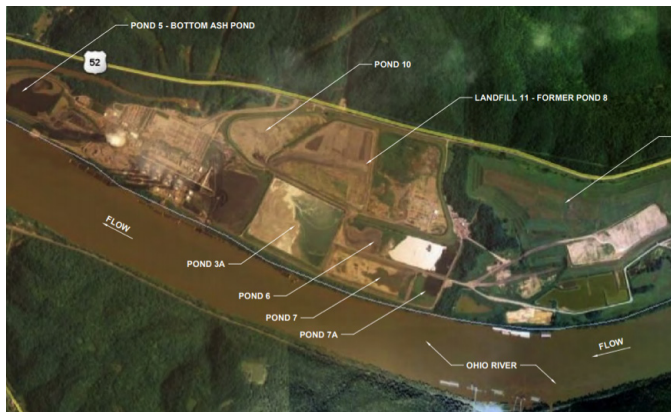
EPA-labeled aerial imagery of the J.M. Stuart coal plant on the Ohio River. Only one of the five coal ash ponds assessed was in “satisfactory” condition.⁶¹ Image: EPA

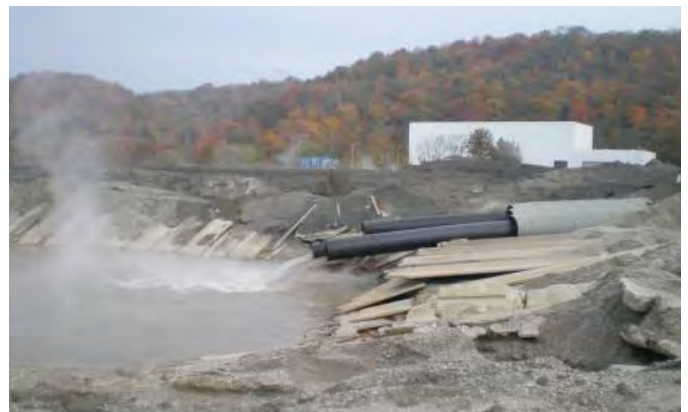
Sluice lines entering “Pond 5” at the J.M. Stuart Station, located in an Ohio River flood zone. Pond 5 was found by an EPA assessment to be in “Poor” condition, and to pose a “Significant” hazard to the surrounding area. Image: EPA
