A Path to Cleaner Water

How investments in America's water infrastructure are protecting waterways

Laura Miller and John Rumpler
Environment America Research & Policy Center

December 2020

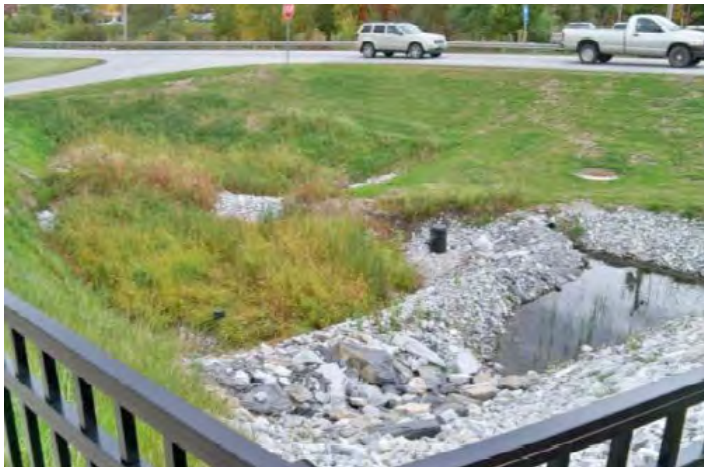
St. Albans Gravel Wetland after completion. Credit: Watershed Consulting

In addition to agricultural best management practices, urban stormwater management is being implemented to reduce phosphorus levels and harmful algal outbreaks in the Bay. To address stormwater runoff pollution in Stevens Brook, the Vermont Agency of Transportation installed a gravel wetland to capture and treat stormwater runoff from the adjacent Park and Ride and roadway. Catch basins direct stormwater into the wetland, where it is filtered through microbe-rich gravel beneath the surface. Native plants above the gravel and along the wetland's slopes absorb additional stormwater and

nutrients.⁵⁴ During storm events, the wetland holds excess water, and filters and releases it slowly into Stevens Brook to prevent erosion and flooding⁵⁵ that may cause additional pollution.

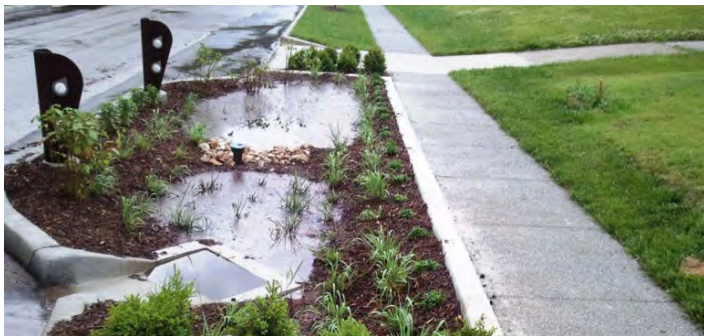
Vegetated stormwater retention basin, curb extension. Credit: Kansas City Water Services

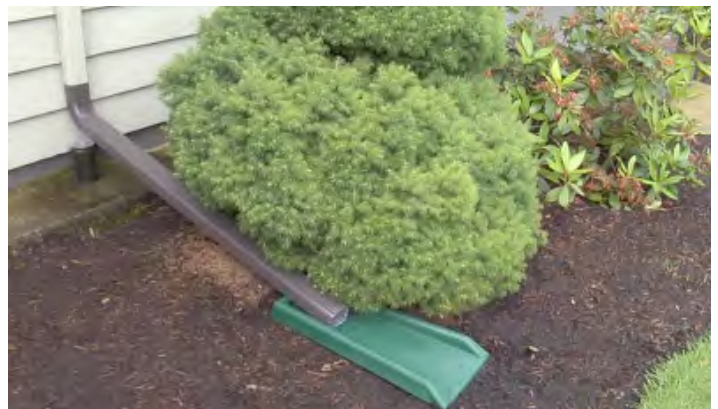
Downspout disconnection as part of the Cornerstone Projects. Credit: City of Portland

One part, the Cornerstone Projects, used green infrastructure to reduce stormwater before reaching the combined sewer system. Projects included downspout disconnections, 3,000 stormwater catch basins, and local stream diversions from the combined system. In addition, the city separated the sewer system in some neighborhoods with new pipes.²¹³
