A Path to Cleaner Water

How investments in America's water infrastructure are protecting waterways

Laura Miller and John Rumpler
Environment America Research & Policy Center

December 2020

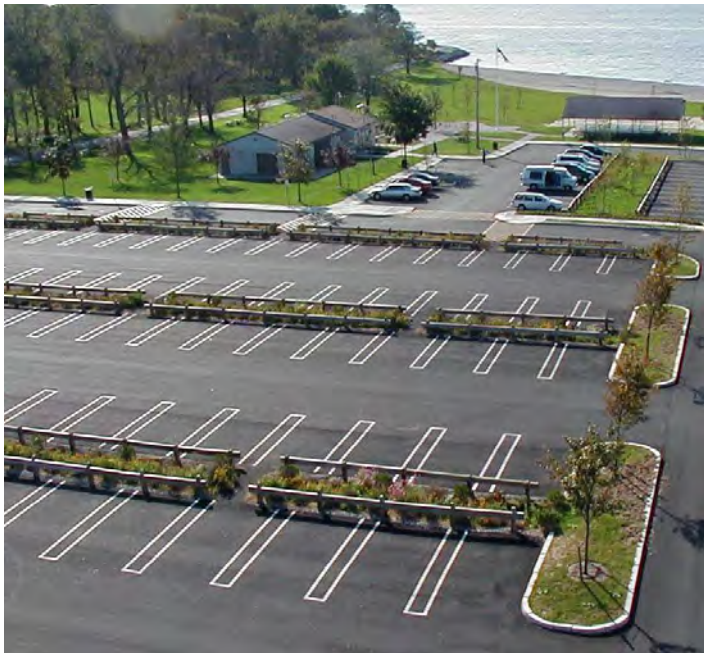
Green Stormwater Infrastructure in Town Beach Parking Lot, Bristol Rhode Island. Credit: Rhode Island Department of Environmental Management

The beach parking lot was rebuilt with a vegetated stormwater channel to collect and treat stormwater, and six rain gardens and three vegetated stormwater basins were built into the parking lot and adjacent play areas.³⁸ All of these systems are designed to slow stormwater runoff as it flows towards the beach, filter it of contaminants using a variety of techniques, and discharge it slowly into the Bay. They collect and treat stormwater from a total of 95 acres from surrounding neighborhoods, roads, and parking lots.³⁹

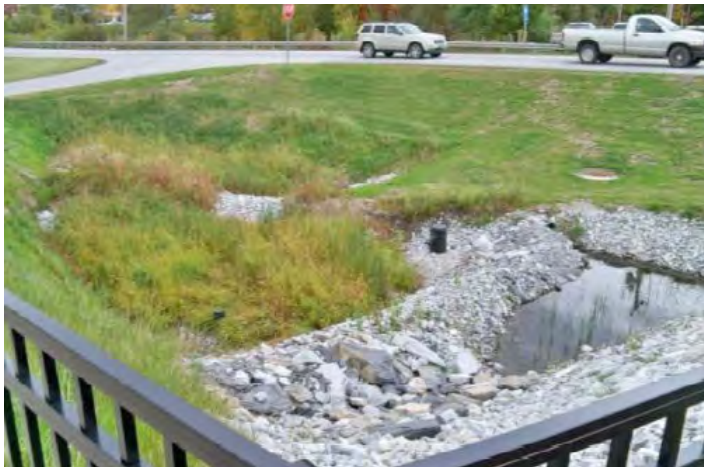
St. Albans Gravel Wetland after completion. Credit: Watershed Consulting

In addition to agricultural best management practices, urban stormwater management is being implemented to reduce phosphorus levels and harmful algal outbreaks in the Bay. To address stormwater runoff pollution in Stevens Brook, the Vermont Agency of Transportation installed a gravel wetland to capture and treat stormwater runoff from the adjacent Park and Ride and roadway. Catch basins direct stormwater into the wetland, where it is filtered through microbe-rich gravel beneath the surface. Native plants above the gravel and along the wetland's slopes absorb additional stormwater and

nutrients.⁵⁴ During storm events, the wetland holds excess water, and filters and releases it slowly into Stevens Brook to prevent erosion and flooding⁵⁵ that may cause additional pollution.

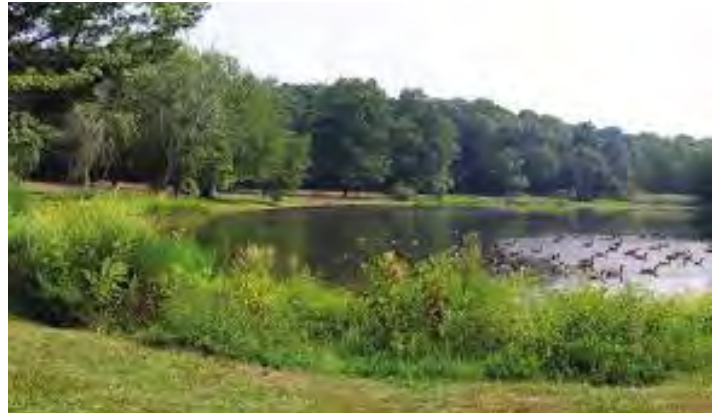
Image of Edgewood Park Pond after project completion. Credit: U.S. EPA

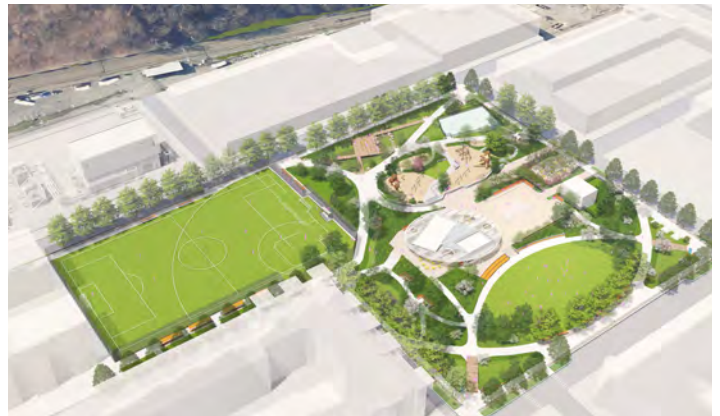
Graphic rendering of the Northwest Resiliency Park design. Credit: City of Hoboken.

The Northwest Resiliency Park, to be completed in 2022, is part of the city's green infrastructure plan. Once constructed, it will be the largest stormwater park in Hoboken to date. To capture and filter stormwater, the design plans for the park include several stormwater gardens and gravel storage under athletic fields. Additionally, plans for the park include an underground stormwater detention system to trap stormwater to prevent flooding and sewage overflows.⁸⁰

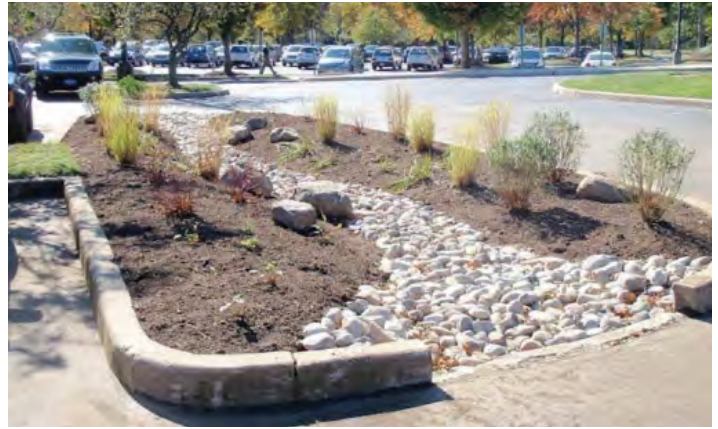
Rain Garden at Subaru of America in Cherry Hill, NJ. Credit: U.S. EPA

Implementation began in 2007, and as of October 2018 approximately 42 rain gardens, one stream restoration, a floating island pond treatment unit, a biofilter wetland, a vegetated stream buffer, and 14 stormwater basins to slow and filter stormwater have been implemented. These systems use native plants to trap and treat stormwater before it reaches the Cooper River.

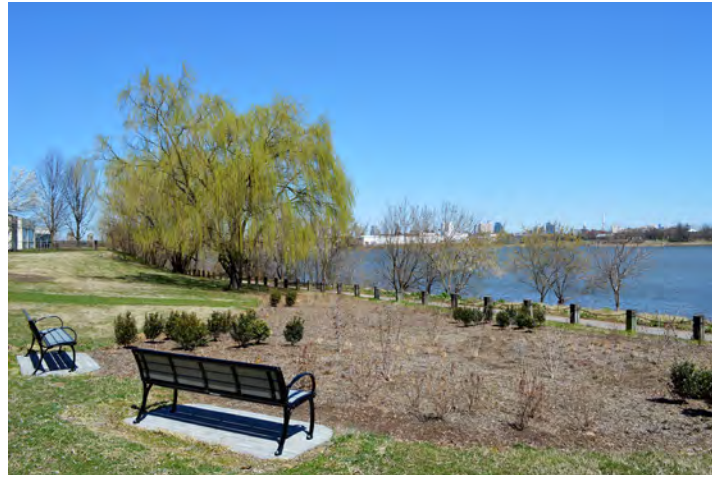
Conservation landscaping using native plants before bloom. Credit: Blue Water Baltimore

This green infrastructure park traps and filters stormwater from the hospital's campus before it reaches the river.¹⁰² The project is estimated to annually prevent 39 pounds of nitrogen, six pounds of phosphorus, and 1.2 tons of sediment from entering the river.¹⁰³

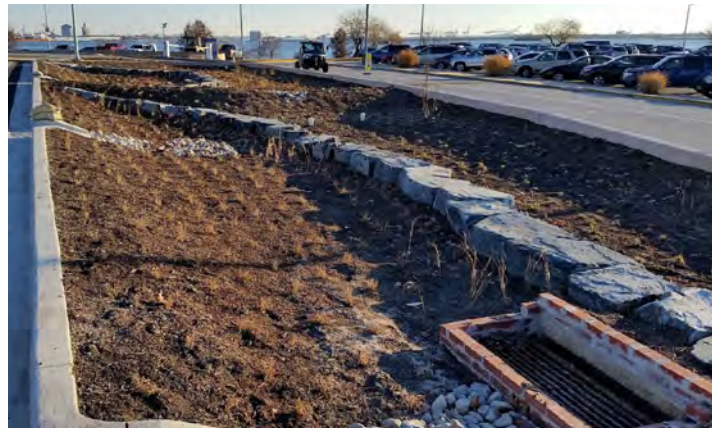
Vegetated stormwater basin in parking lot after planting. Credit: Blue Water Baltimore

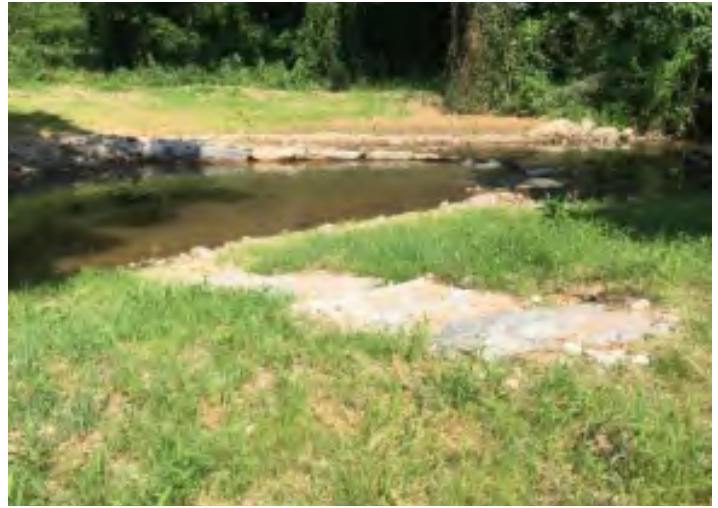
Mill Creek erosion control. Credit: EPA

Thanks to these projects, Mill Creek is once again clean enough to support fish and wildlife. The green infrastructure implemented around Mill Creek increased the amount of stormwater able to soak into the ground and decreased the volume of urban runoff. Vegetation in these projects takes in nutrients from the stormwater, therefore decreasing nutrients and organic matter in the creek.

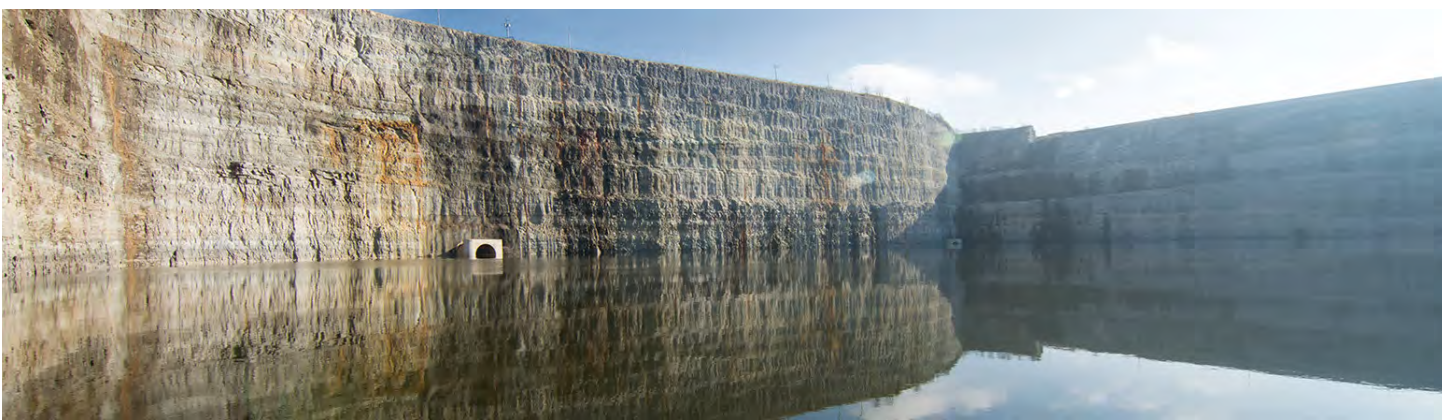
TARP Reservoir, Credit: MWRD

The Thornton Composite Reservoir can hold 7.9 billion gallons of storage in the retired portion of an old quarry.¹²⁷ It is the largest portion of TARP completed to date, and the largest combined sewer reservoir in the world as of 2016.¹²⁸

The reservoir collects water from tunnels before pumping it to the Calumet Water Reclamation Plant for treatment when capacity allows. This plant was upgraded to disinfect the water it treats in order to protect public health and allow a variety of recreational uses in the Chicago Area Waterway System where it discharges.

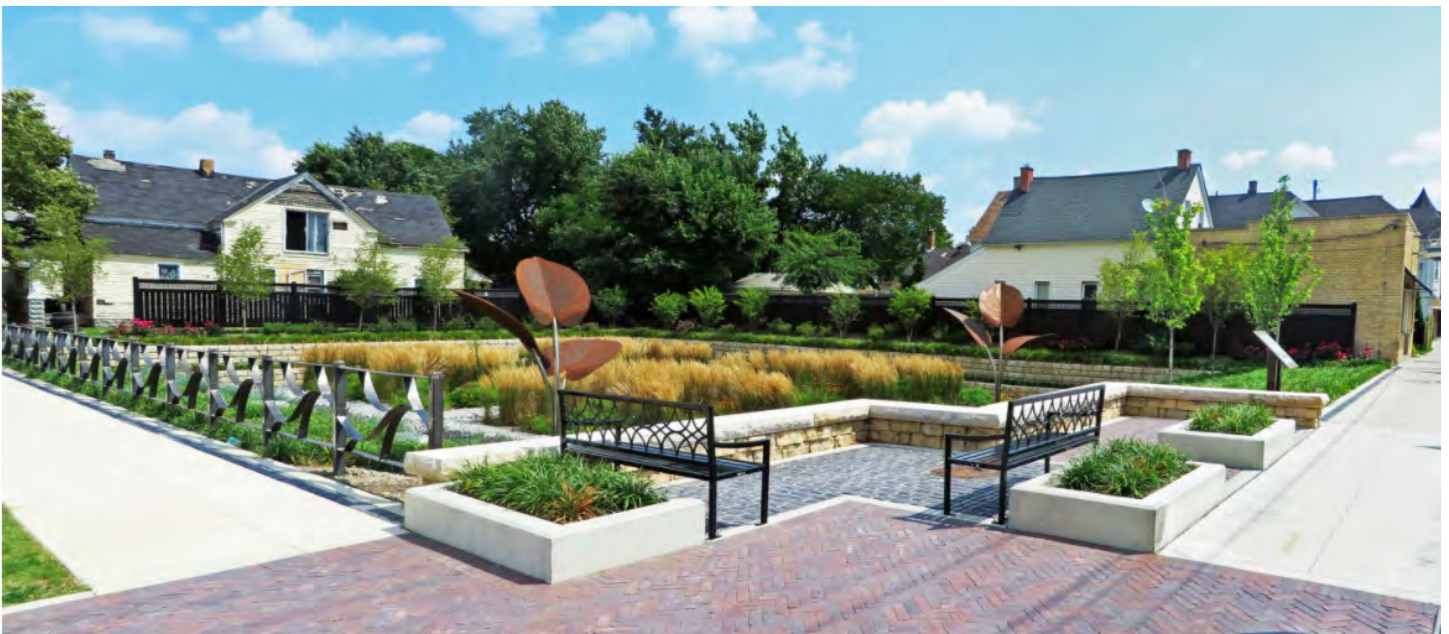
TARP Reservoir. Credit: MWRD

TARP will cost a projected \$3.8 billion upon completion, including the cost for tunnels, the Thornton Reservoir, and the new McCook Reservoir currently underway.¹³⁴

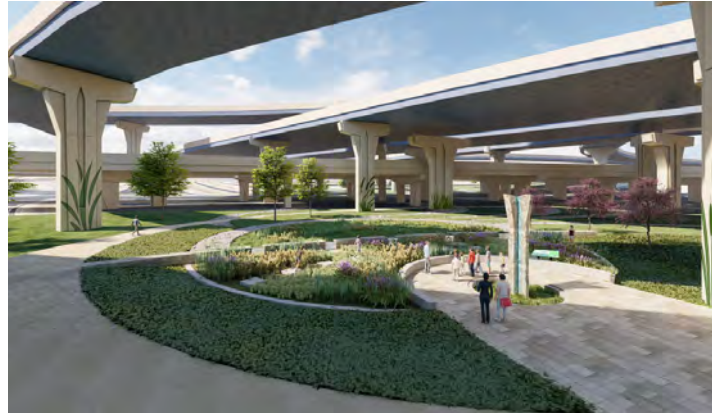
Graphic rendering of Milwaukee Underpass green stormwater infrastructure park design. Credit: Human Nature and Stand Associates

Having spent considerable sums on grey “end of pipe” solutions, MMSD is now turning to green infrastructure to meet its goal of eliminating overflows. One project is being designed to turn a 16-acre site beneath Interstate 794 into a green stormwater management park that will trap and filter runoff from the freeway’s bridges.¹⁴⁹ The project’s preliminary master plan includes a pre-treatment and treatment vegetated basins, and a meadow with native vegetation.¹⁵⁰

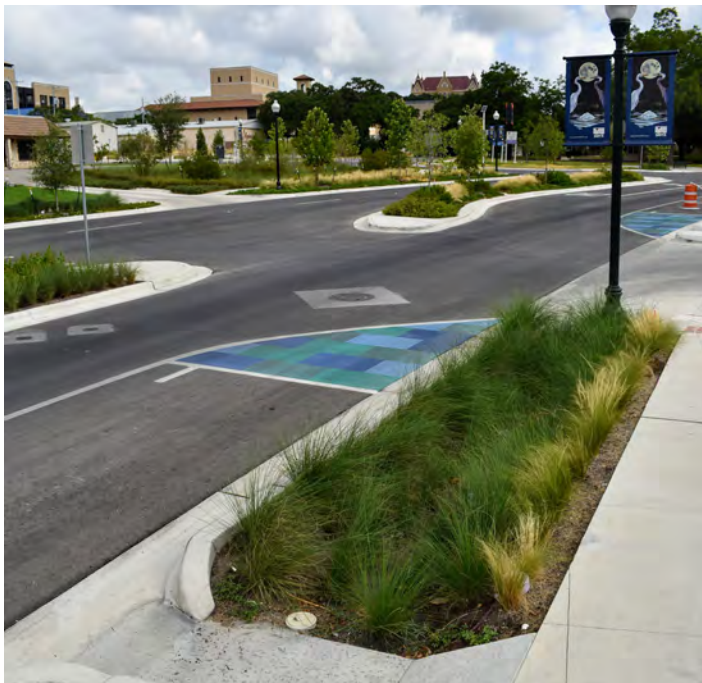
CM Allen Parkway after completion. Credit: City of San Marcos

The CM Allen Parkway in San Marcos runs parallel to the San Marcos River. When the parkway required updates¹⁵⁷ the city used the construction as an opportunity to protect the river's clean water.

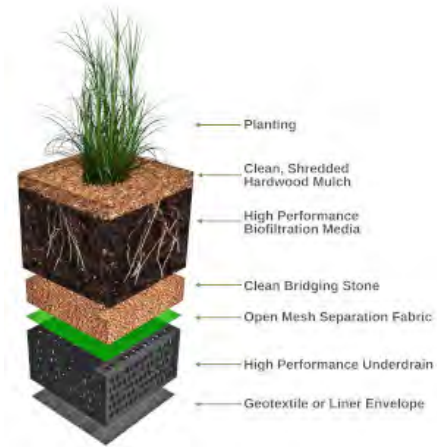
Focal Point biofiltration system. Credit: Convergent Water Tech

The road's redesign included nature-based stormwater management features. Traditional vegetated stormwater management and FocalPoint filtration systems were installed along road medians and edges. Using native plants and soil that allowed rainwater to soak into the ground, these features filter stormwater runoff from the roadway and downtown area before it reaches the river.¹⁵⁸

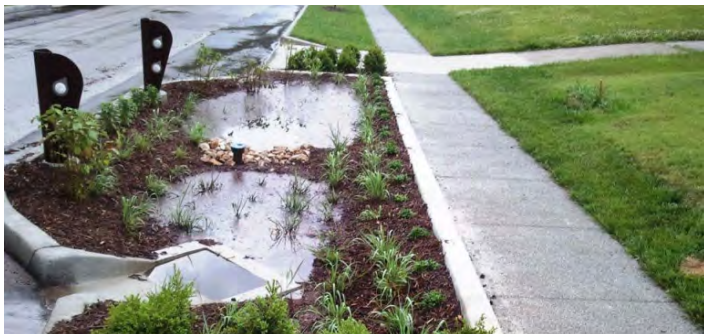
Vegetated stormwater retention basin, curb extension. Credit: Kansas City Water Services

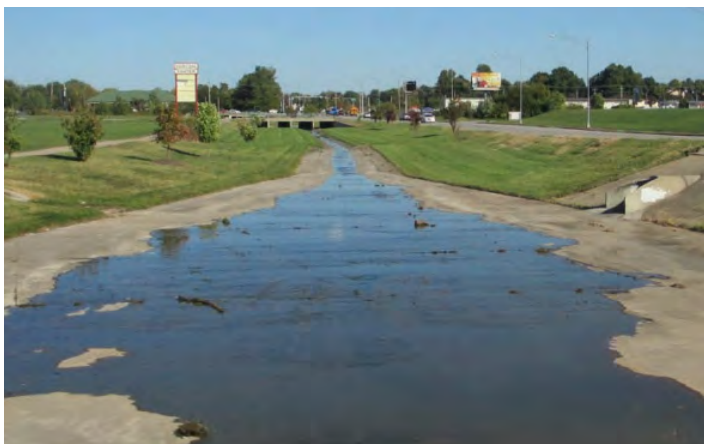
South Creek before restoration. Credit: City of Springfield and James River Basin Partnership

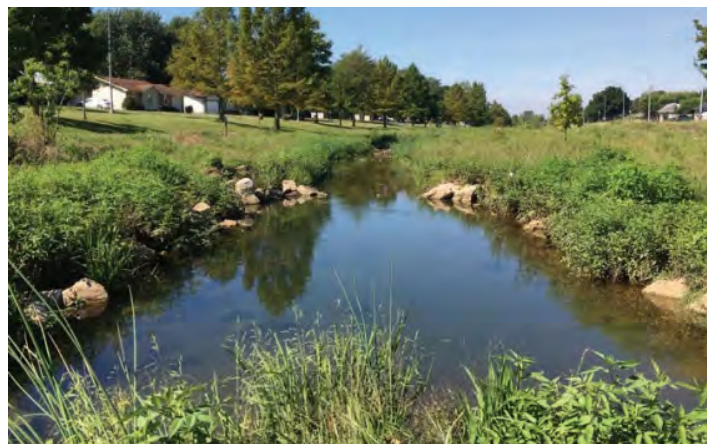
South Creek after restoration, with vegetated stormwater filtration systems at outfalls along creek. Credit: City of Springfield and James River Basin Partnership

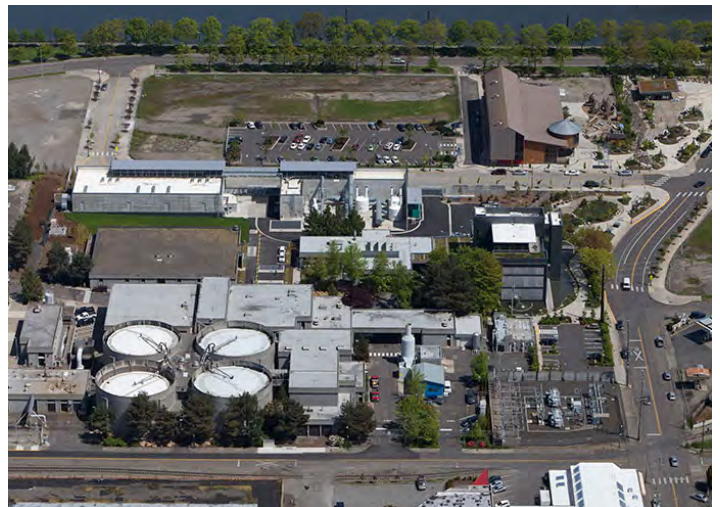
Budd Inlet wastewater treatment plant. Credit: LOTT Clean Water Alliance

Like many coastal treatment plants, LOTT is vulnerable to sea level rise and flooding. To increase resilience and ensure the facility will function for years to come, LOTT engaged in a joint planning effort to prepare the Olympia Sea Level Rise Response Plan in 2018-2019 with the city of Olympia and port of Olympia and is now participating in efforts to implement the plan.²⁰⁵

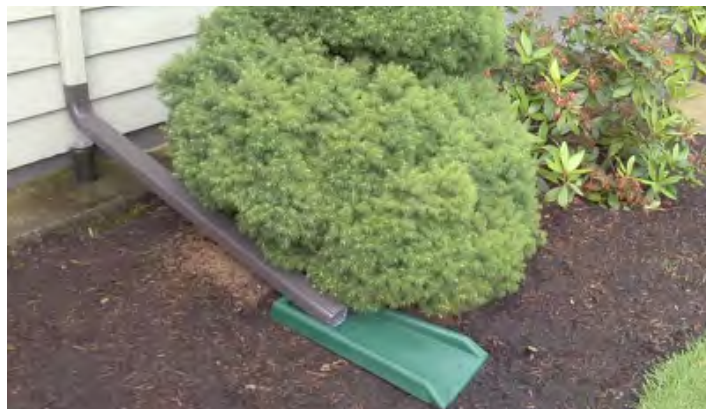
Downspout disconnection as part of the Cornerstone Projects. Credit: City of Portland

One part, the Cornerstone Projects, used green infrastructure to reduce stormwater before reaching the combined sewer system. Projects included downspout disconnections, 3,000 stormwater catch basins, and local stream diversions from the combined system. In addition, the city separated the sewer system in some neighborhoods with new pipes.²¹³
